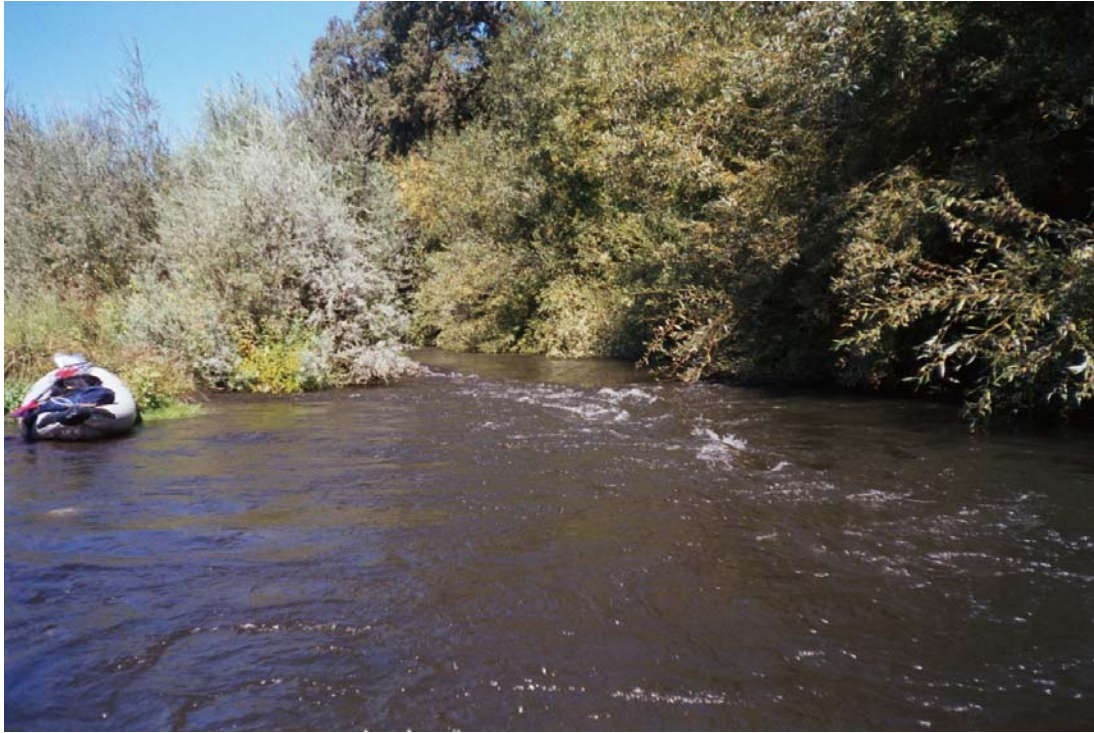
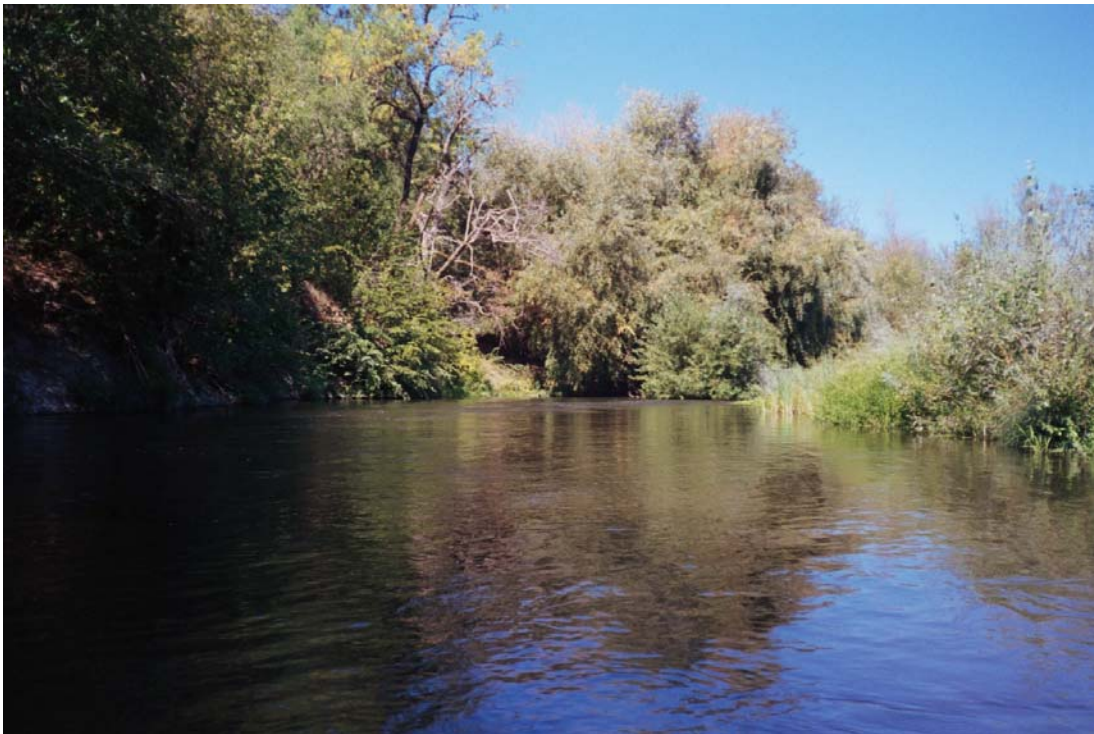
Figure 12: Ukiah Reach, Segment U7. This segment contained 91% flatwater (bottom) and 9% riffle (top) habitats. No steelhead were observed.

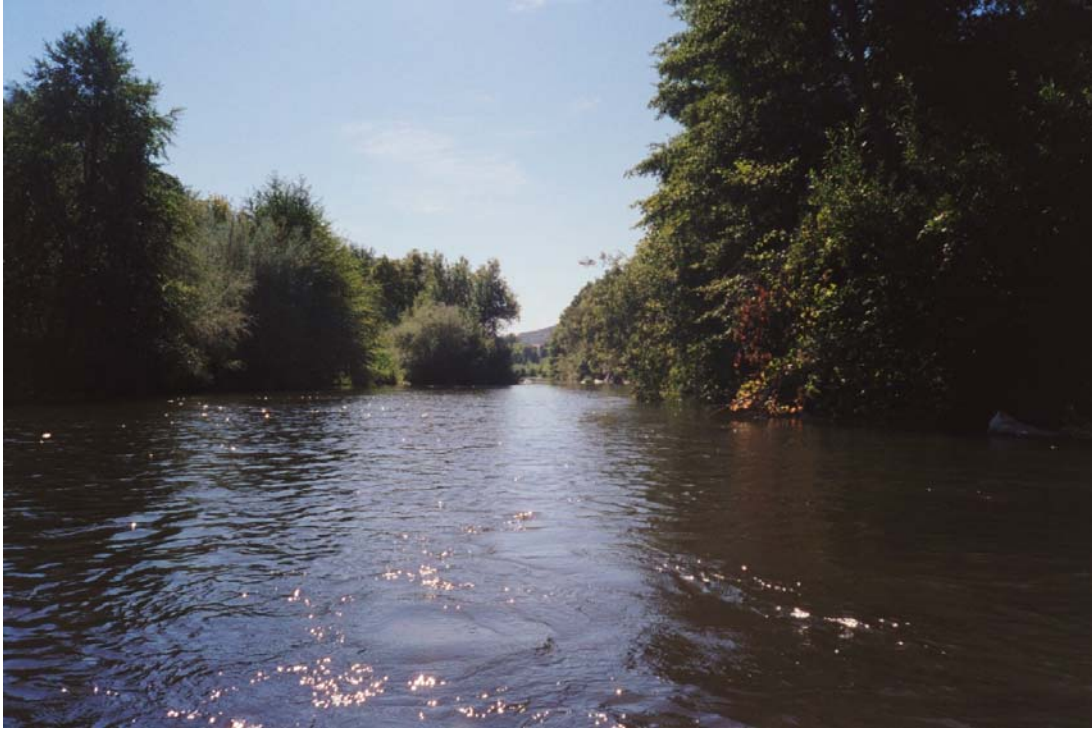
Figure 13: Ukiah Reach, Segment U8. This segment contained primarily flatwater habitat with a well-developed riparian canopy. No steelhead were observed.

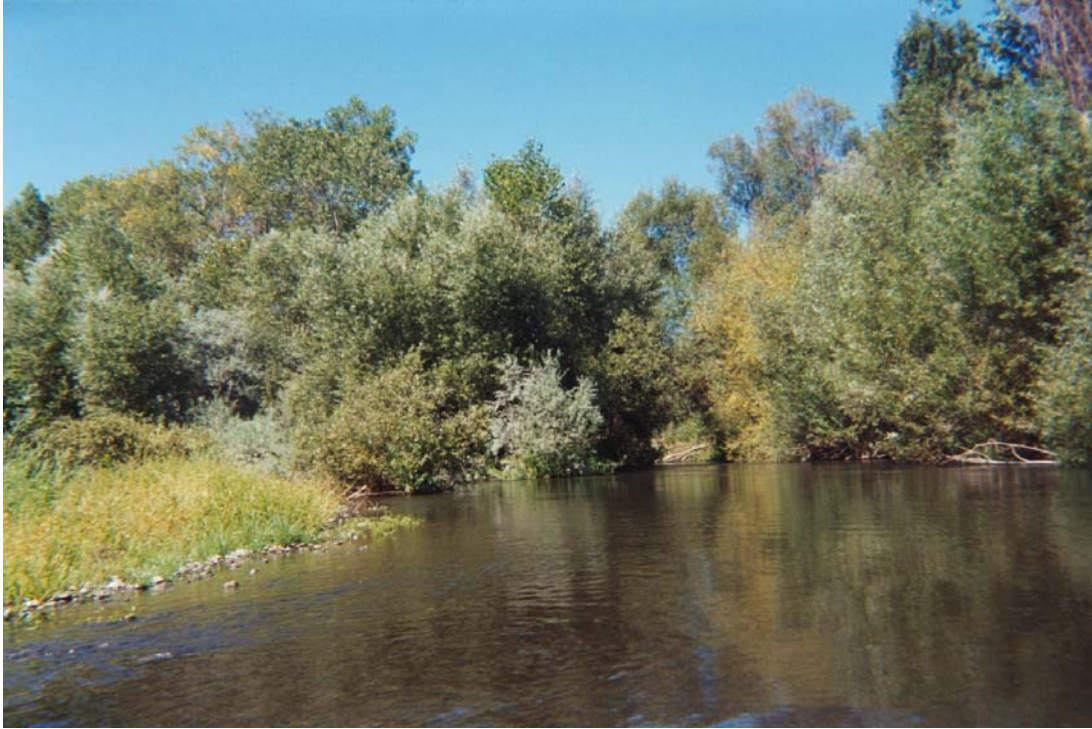
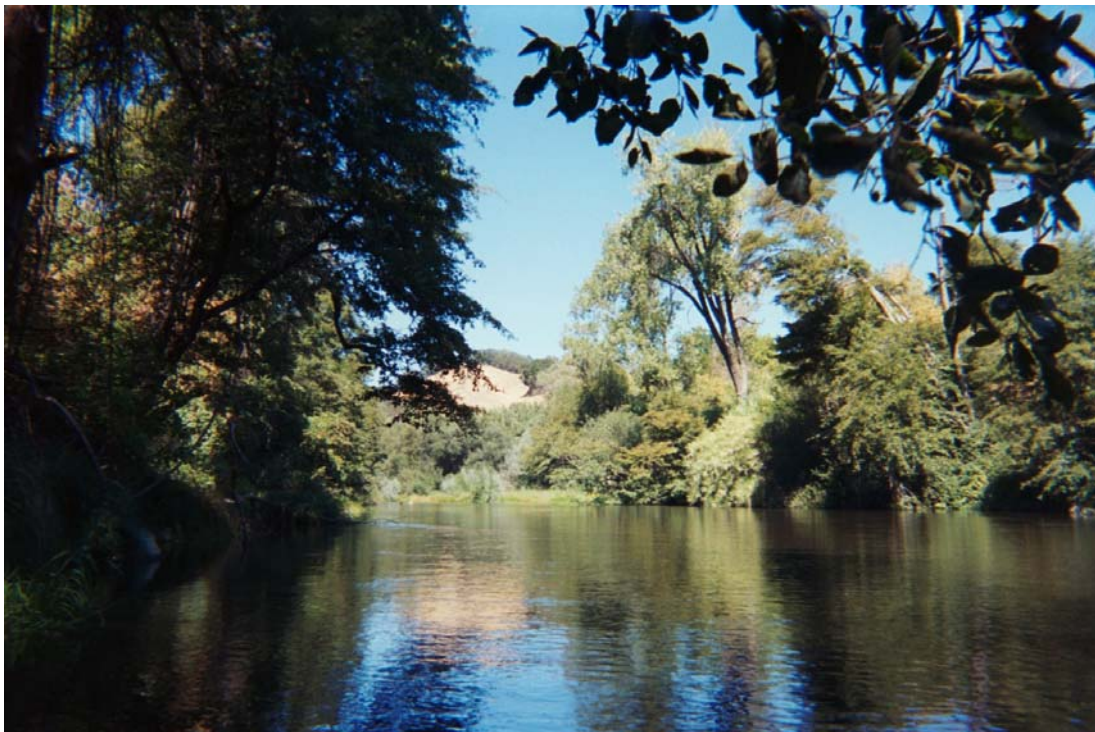
Figure 14: Ukiah Reach, Segment U9. This segment consisted entirely of flatwater habitat with vegetated gravel bars (top) and well-developed riparian canopy (bottom). No steelhead were observed.

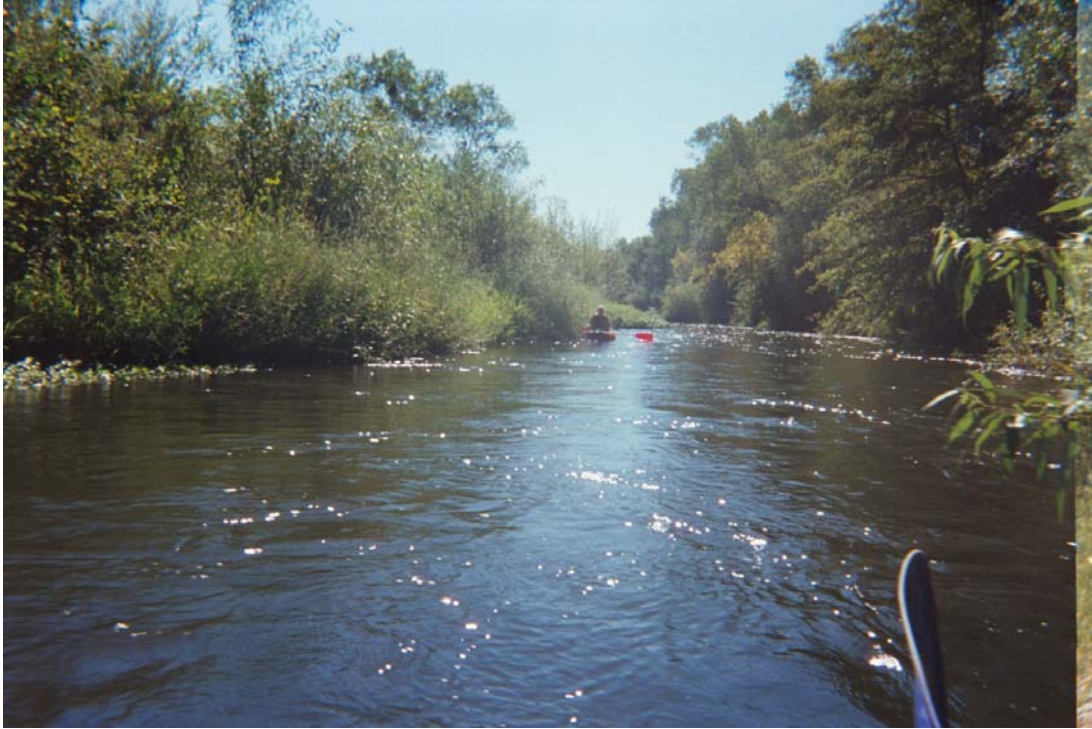
Figure 15: Ukiah Reach, Segment U10. This segment contained entirely flatwater habitat with well-developed riparian canopy (top) and broad vegetated gravel bars (bottom). No steelhead were observed.

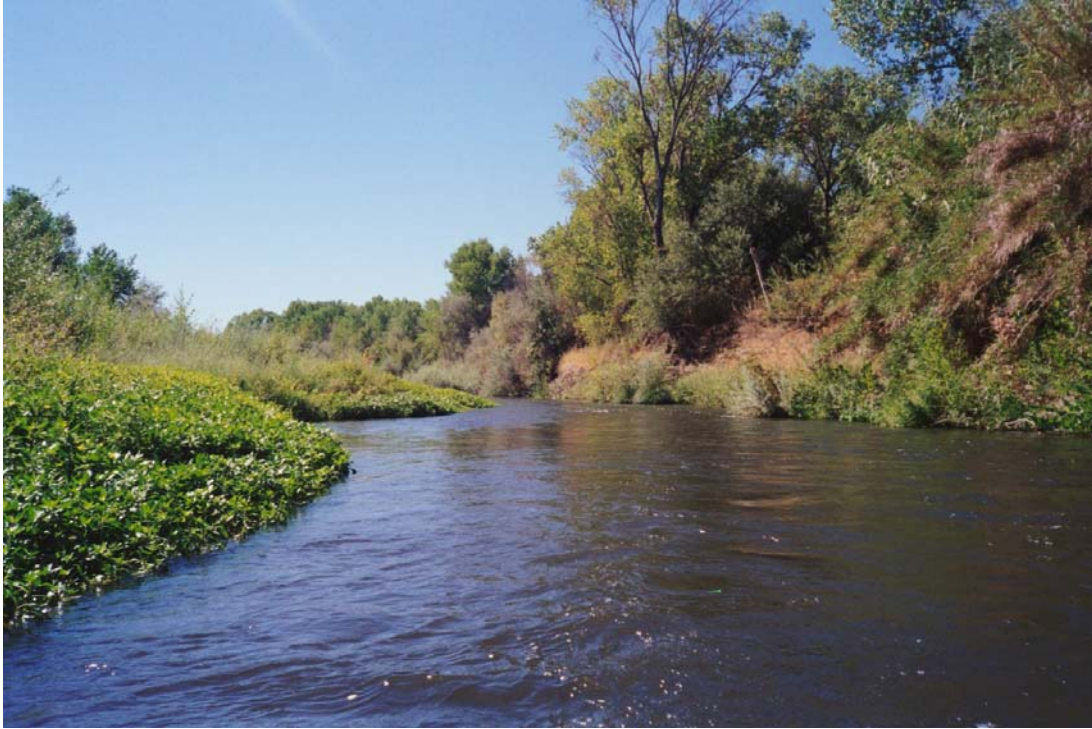
Figure 16: Ukiah Reach, Segment U11. This segment contained entirely flatwater habitat with open to dense riparian canopy and gravel bars vegetated with sandbar willow and water primrose. One steelhead was observed in this segment.
